Leak Detection & Repair

COMMONWEALTH UTILITIES CORPORATION WATER DIVISION

Leak Detection and Repair Phase II

Leak Detection and Repair – Phase II

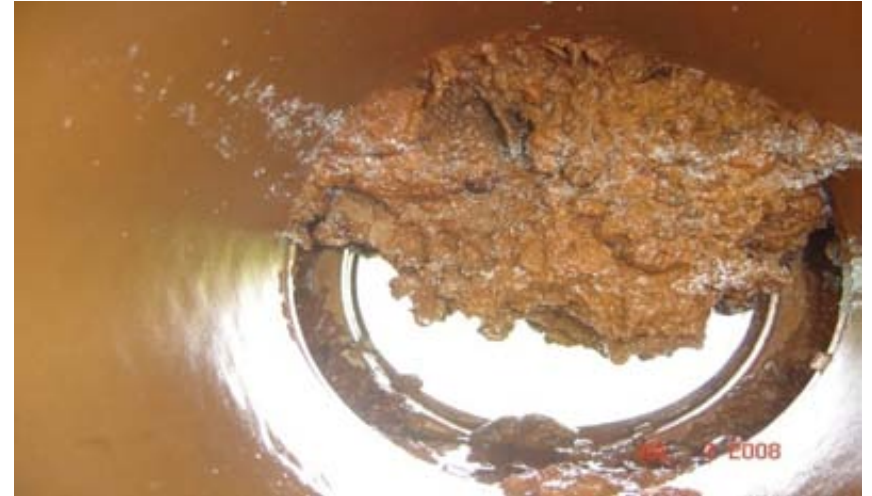
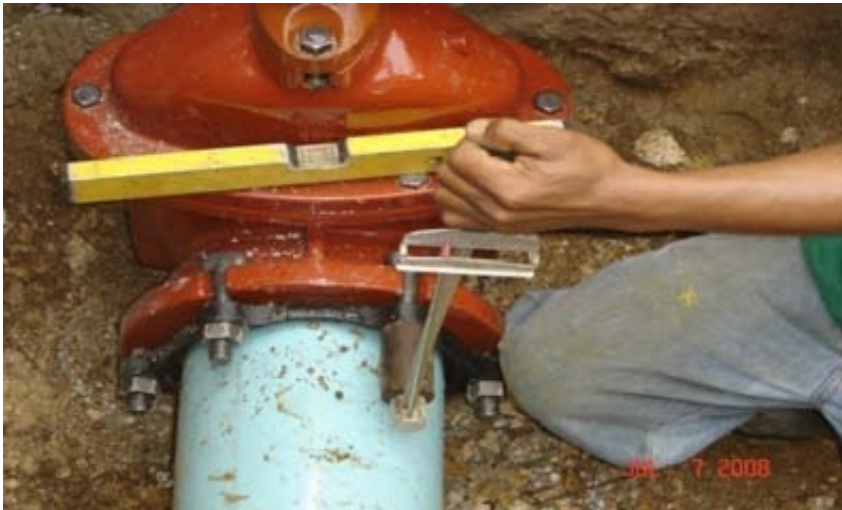
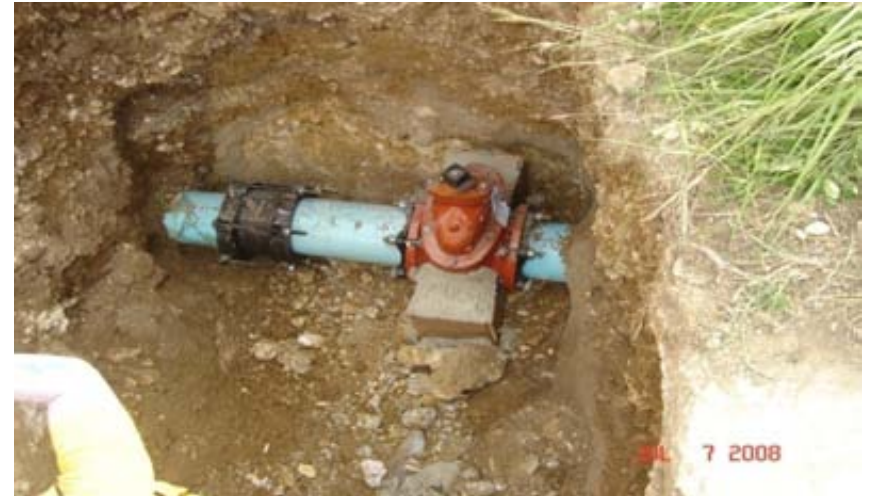
Gate Valve Replacement—8" Ø Gate Valve
Koblerville

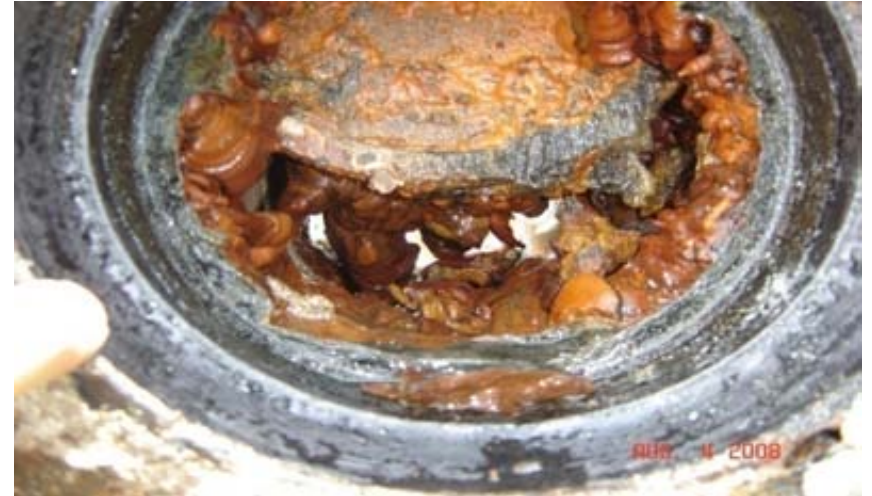
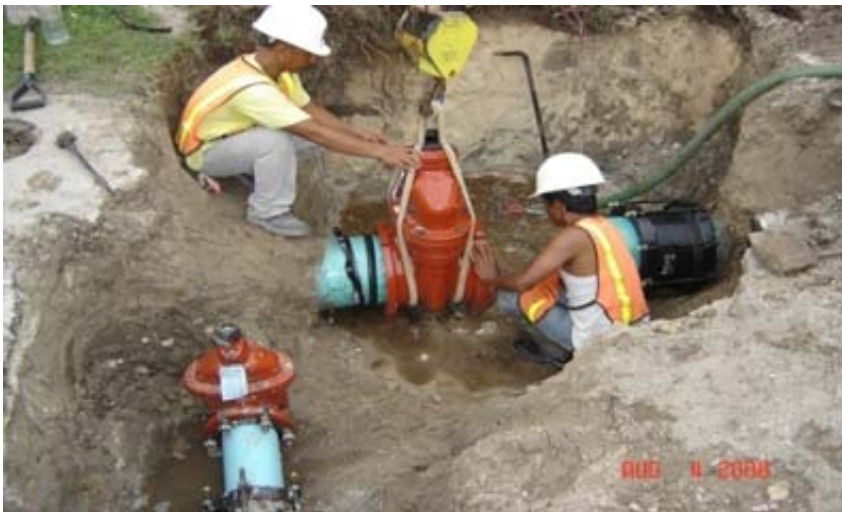
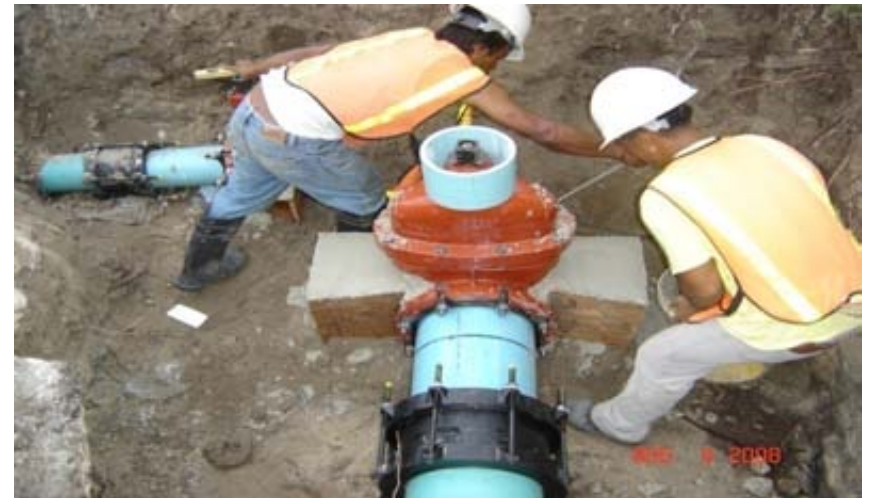
San Antonio

Gate Valve Replacement –6" and 12" Ø Gate Valve

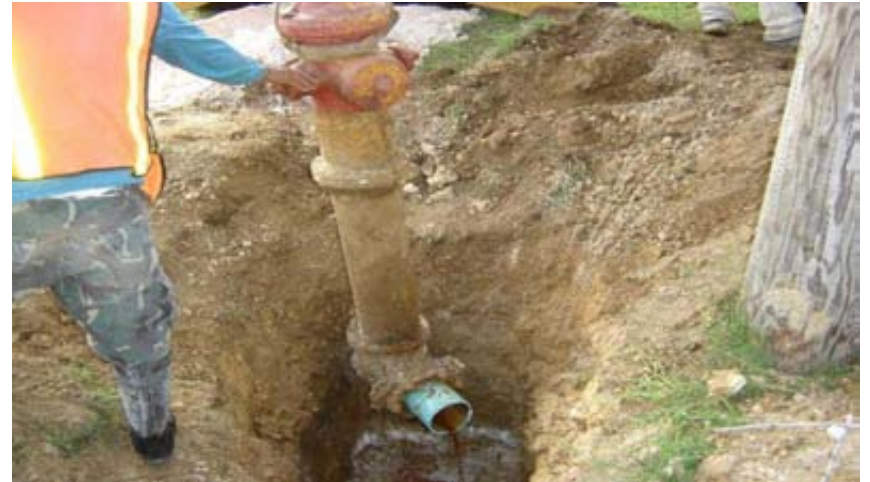
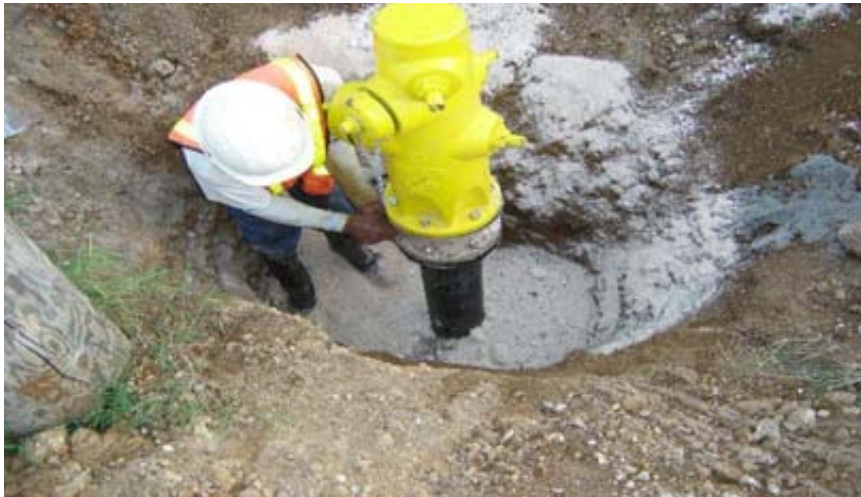
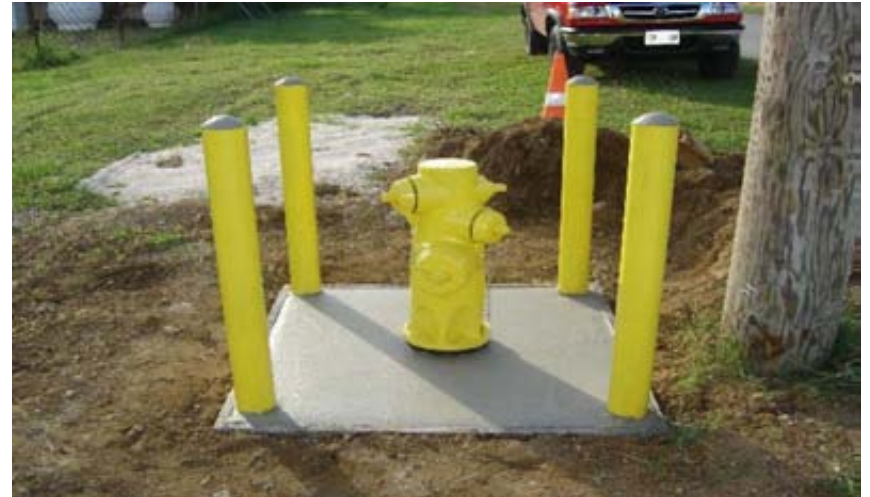
Replacement of Fire Hydrant & Assemblies
Koblerville

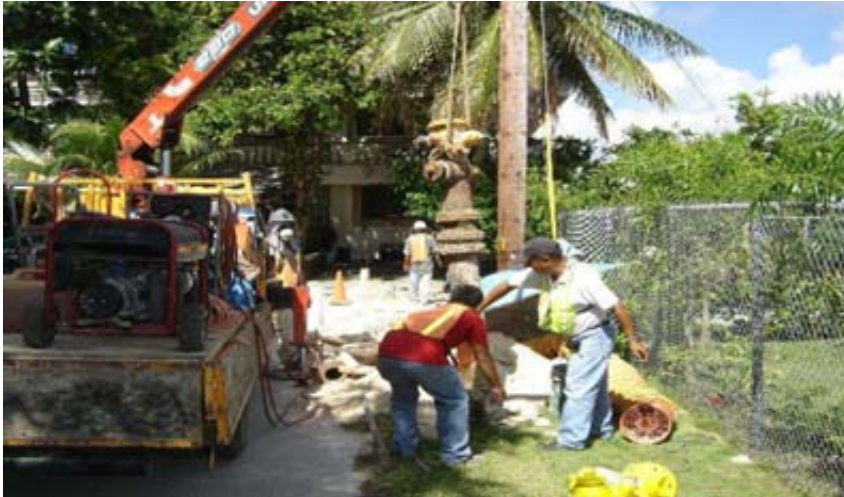
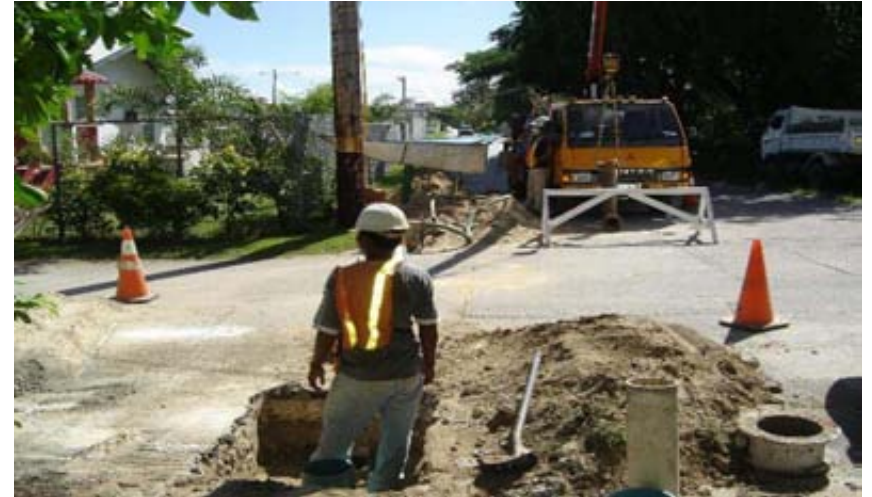
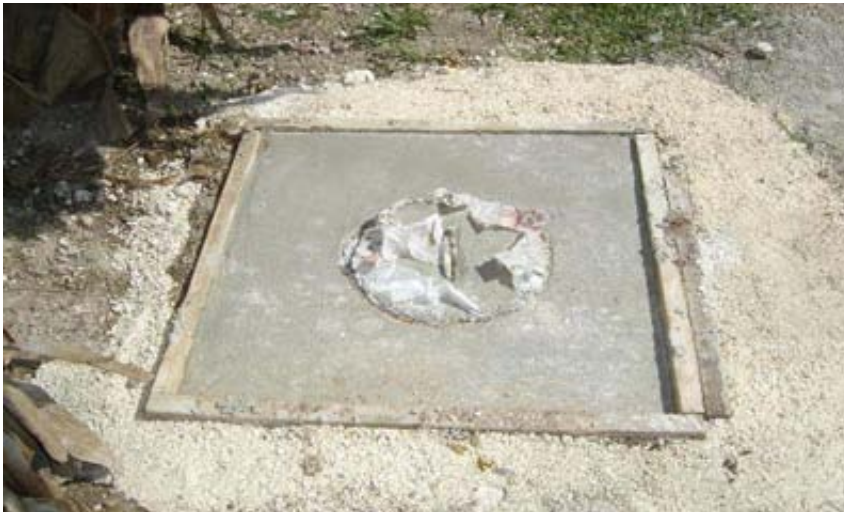
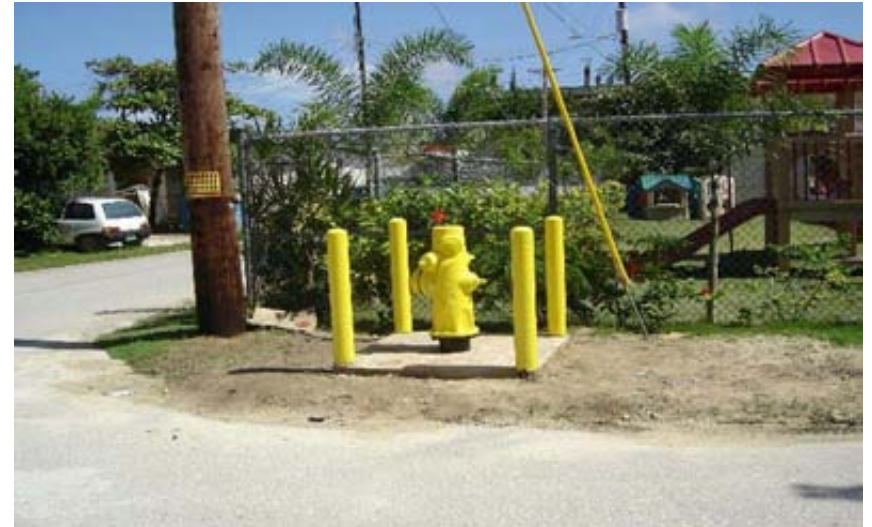
San Antonio

Replacement of Fire Hydrant & Assemblies

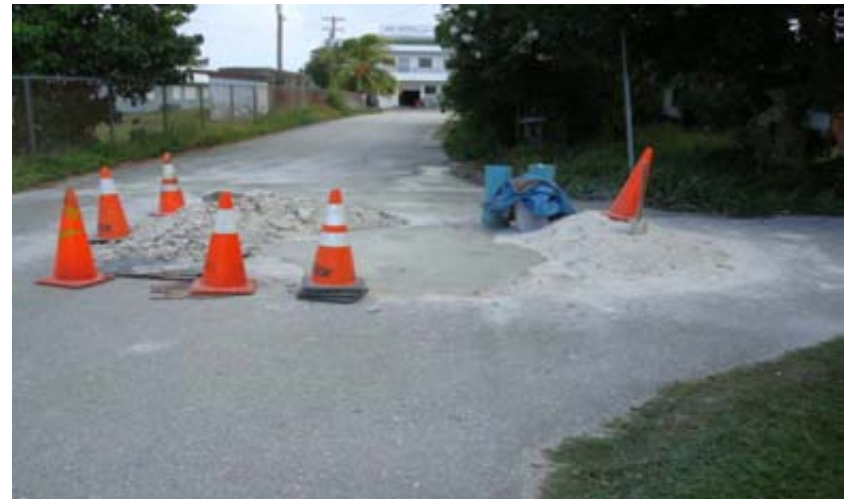
Valve Box Raising
Chalan Kanoa

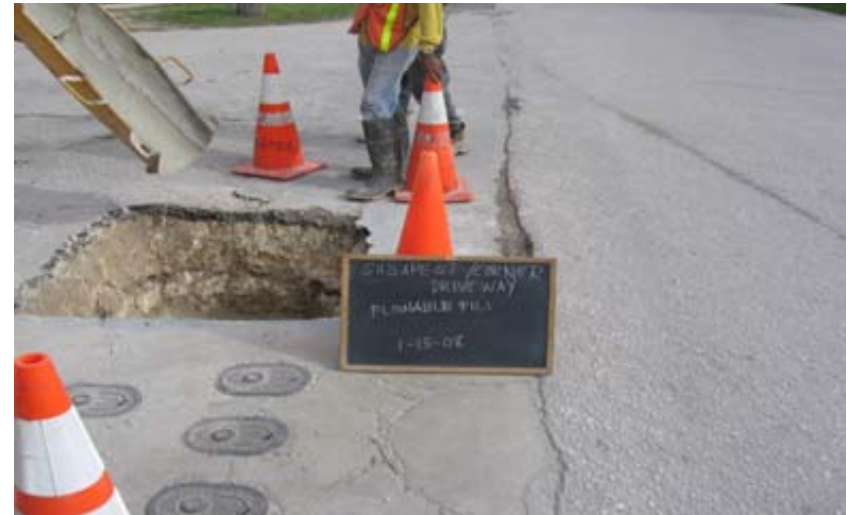
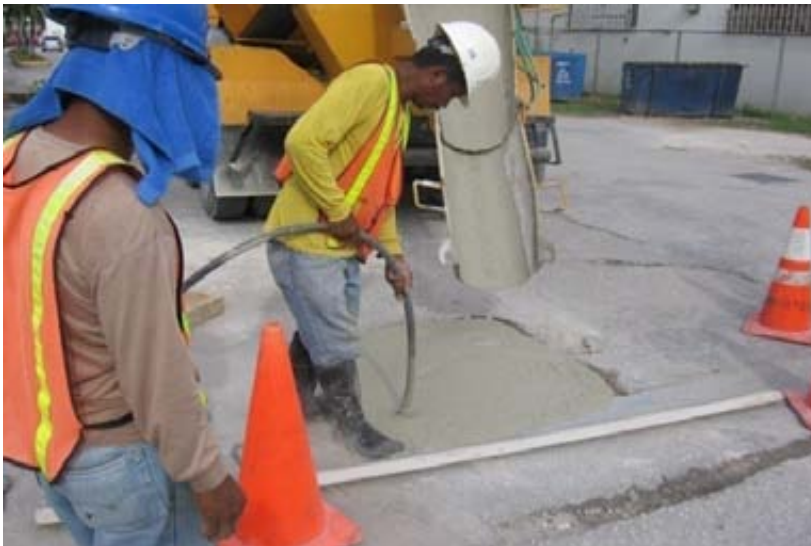
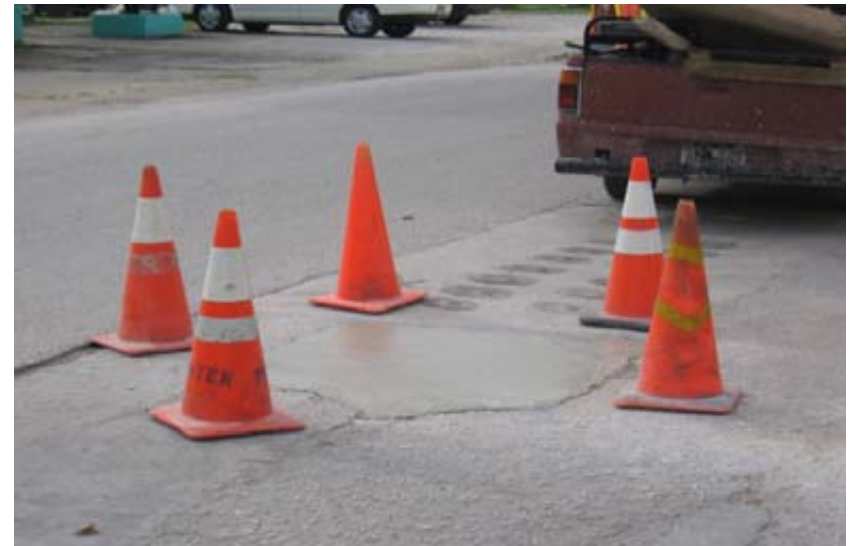
Potholing
Susupe

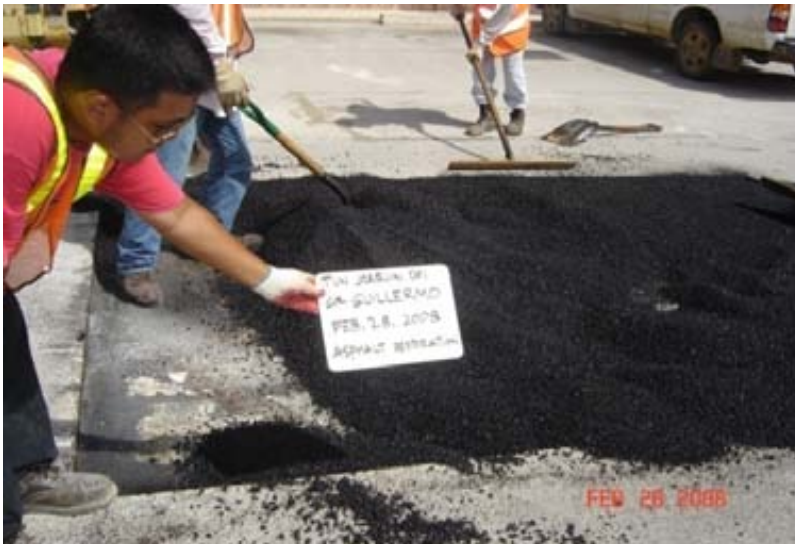
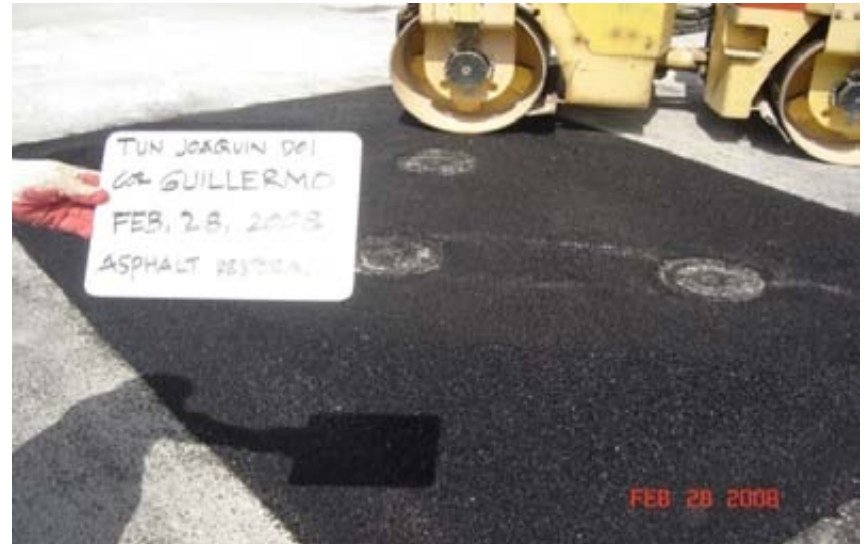
Asphalt Restoration
Chalan Kanoa

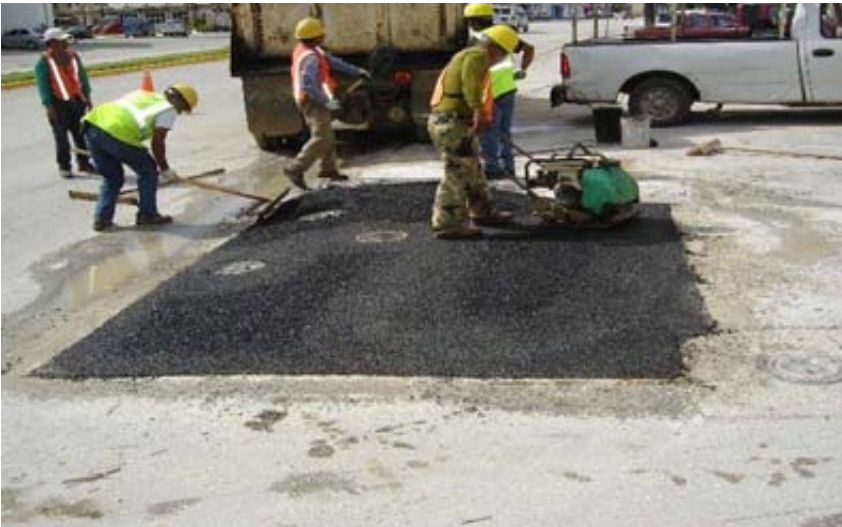
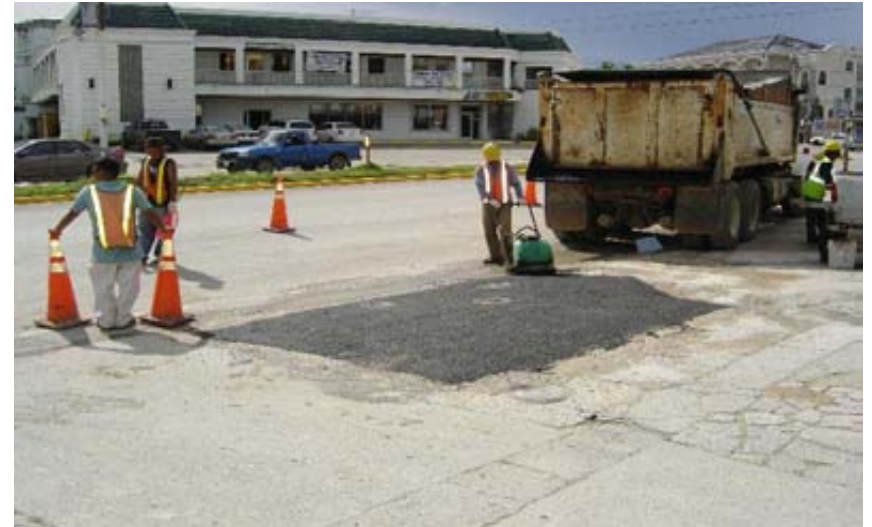
Chalan Piao

Asphalt Restoration

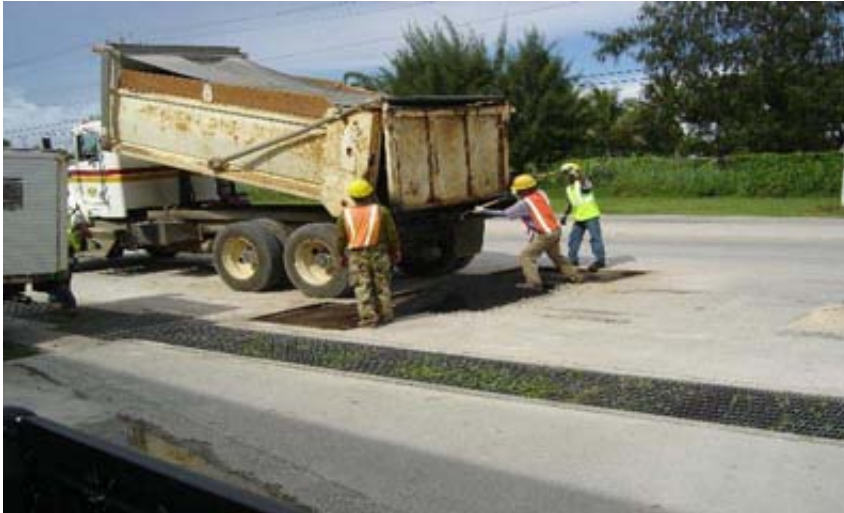
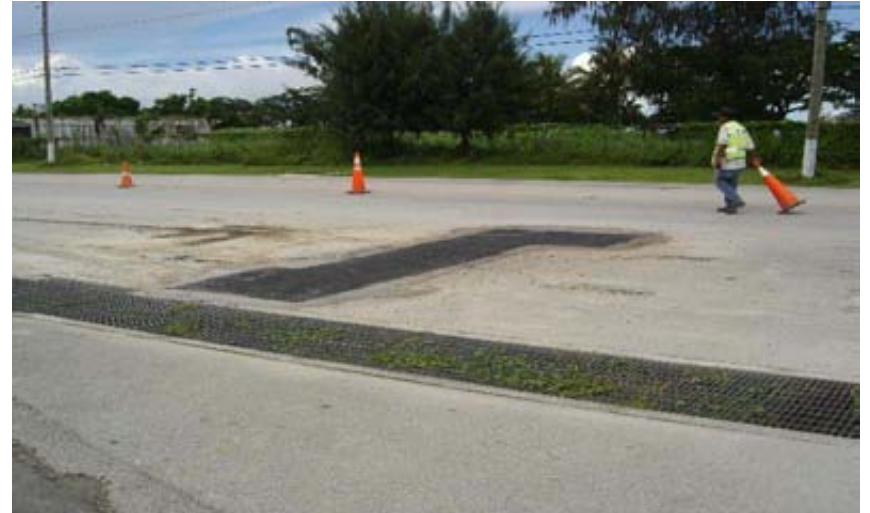
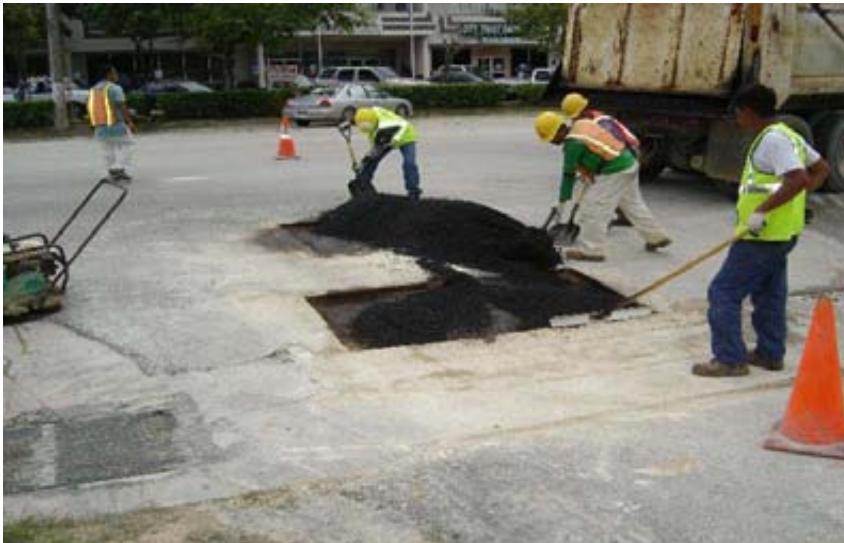
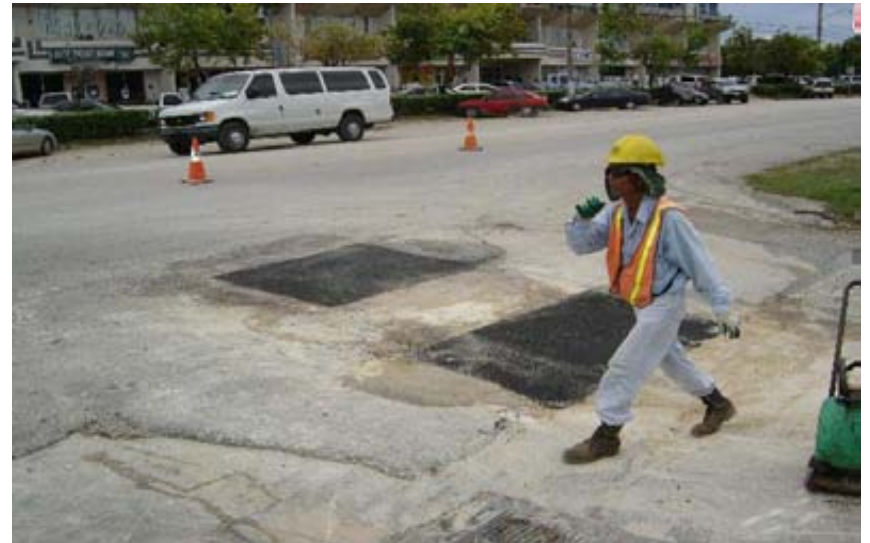
Asphalt Restoration
San Antonio

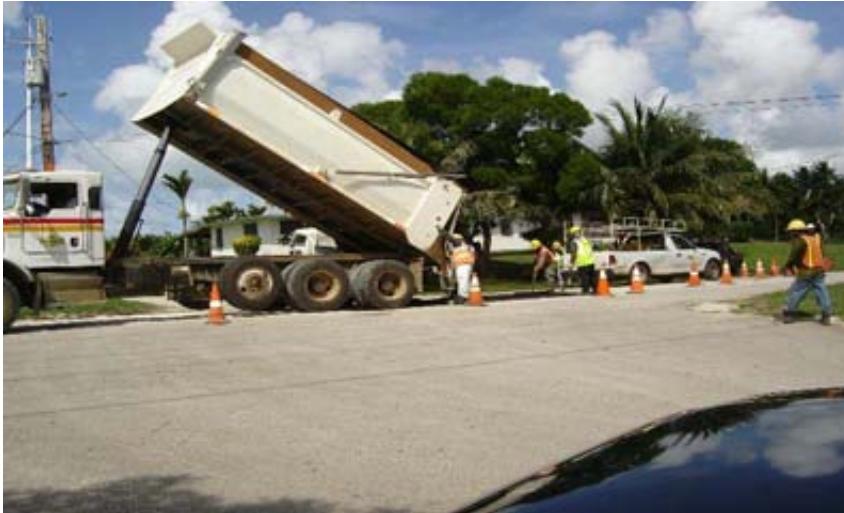
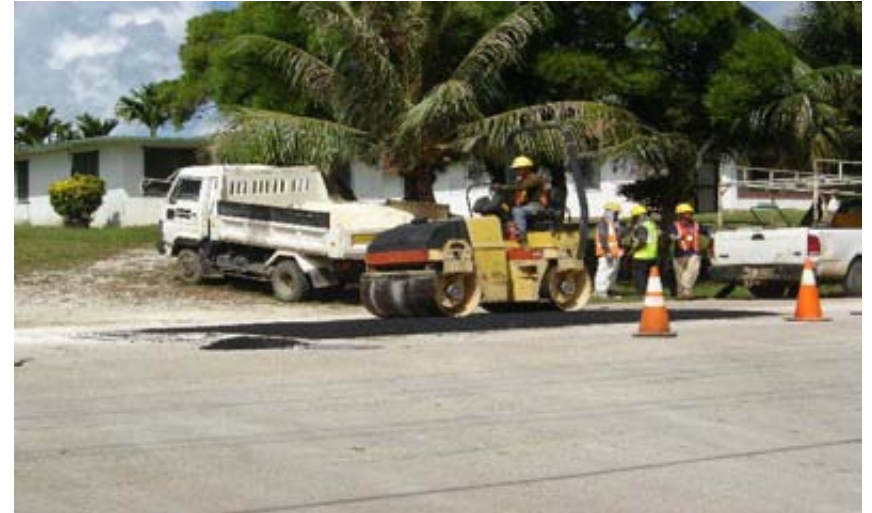
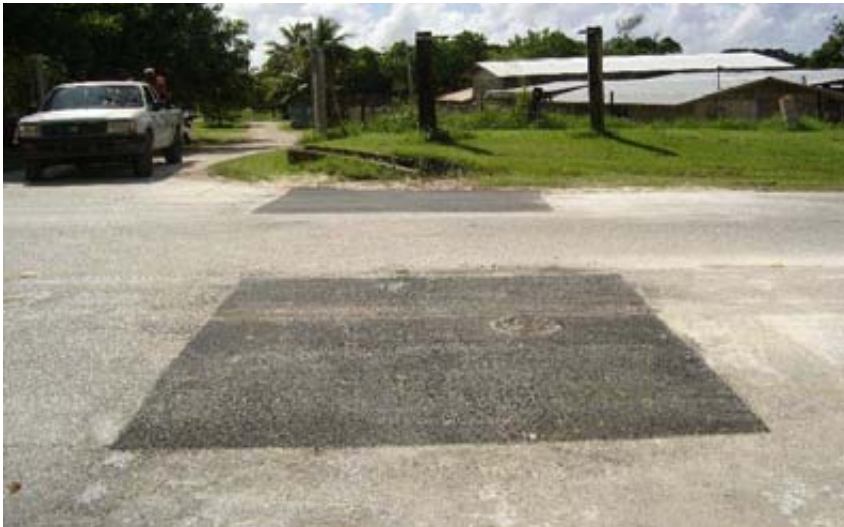
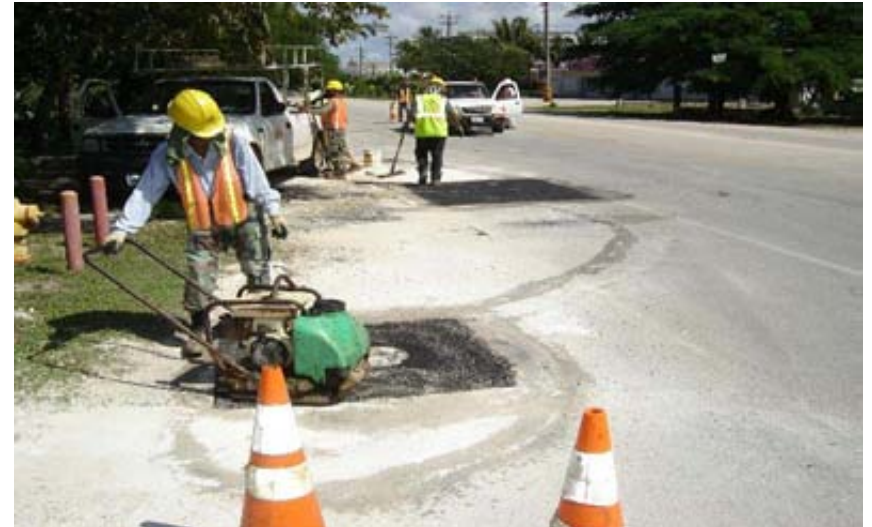
Asphalt Restoration
